Eagle Eye

Building Inspection Report Sample Report

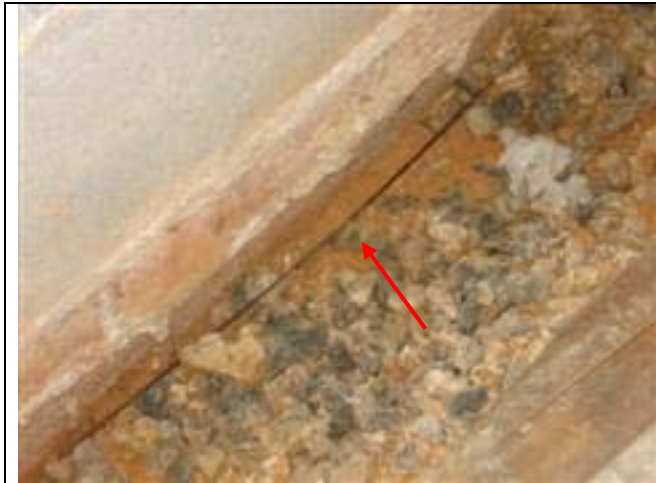
- **Investigate:** The crawl space is dry with very little evidence of any bulk water intrusion. Some evidence can be seen at the front and right side foundation wall where water has previously streamed. A flexible drain has been installed along part of the front wall in an unprofessional manner. If greater water intrusion should occur this system could be improved to perform better.
- **Investigate:** Evidence of wood destroying insect activity was observed at the left front corner in the crawl space and there is risk of additional hidden damage. If the property has not already been treated, a licensed pest control specialist should be consulted. Wood destroying insects can do a substantial amount of damage to the wood structural components of a home.

Evidence of previous water streaming along inside of foundation walls.

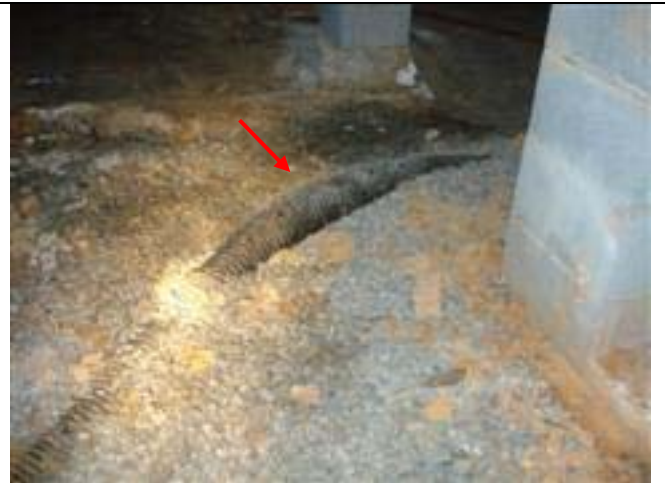
Crawl space drain conduits “porpoising” creates blockages in drain.

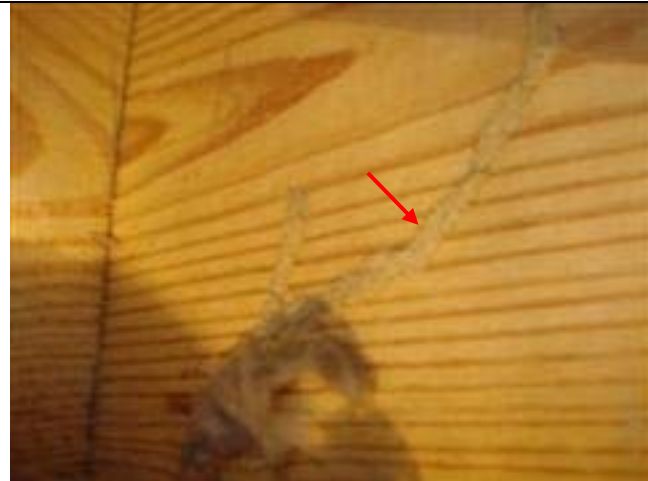
2. **Investigate:** Evidence of wood destroying insect activity was observed at the left front corner in the crawl space and there is risk of additional hidden damage. If the property has not already been treated, a licensed pest control specialist should be consulted. Wood destroying insects can do a substantial amount of damage to the wood structural components of a home.

Insect tunneling on left front floor sills.

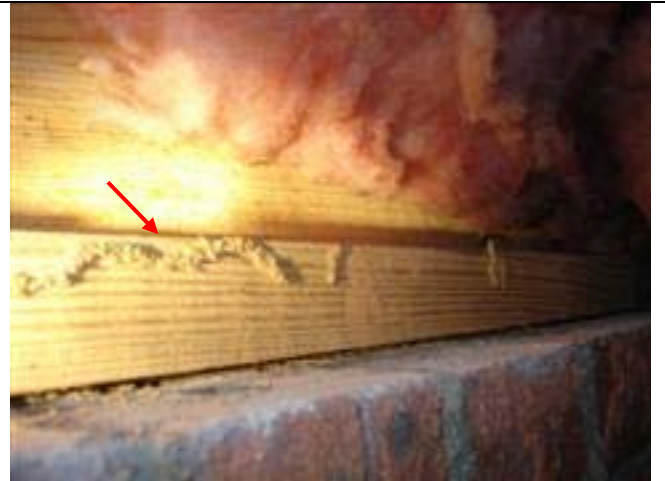
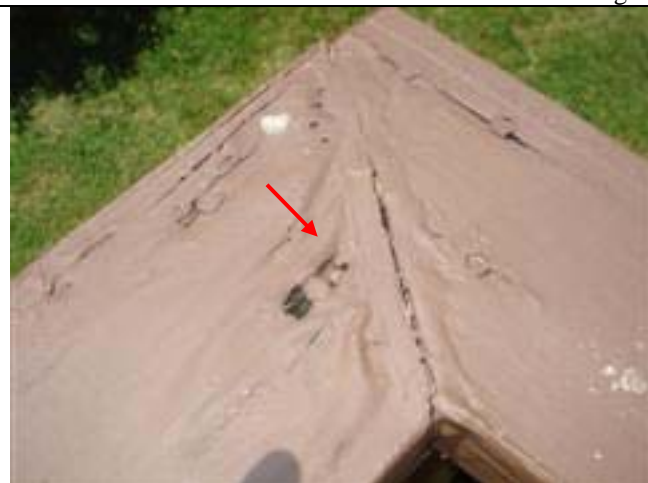
Wooden porch railing suffered moisture damage at right side.

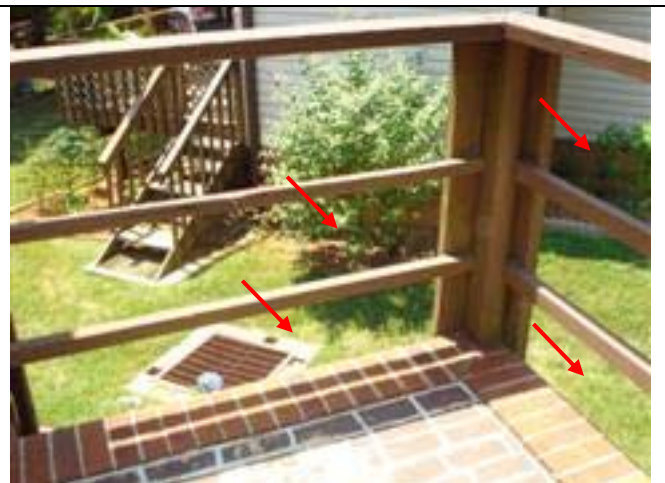
Right side porch railing openings are unsafe for children.

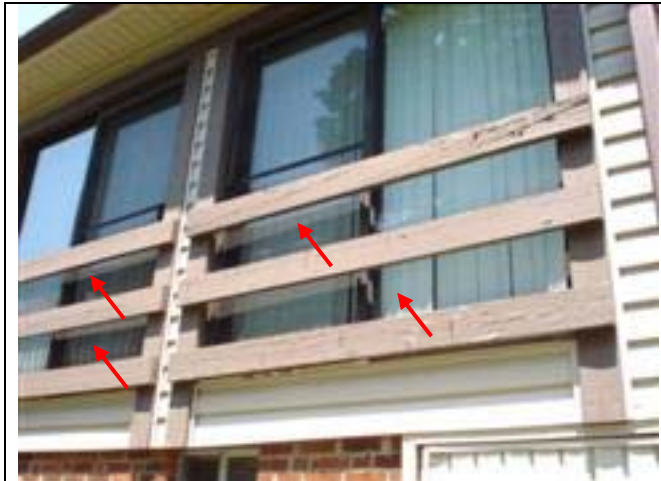
Railing openings at sliding doors are unsafe for children.

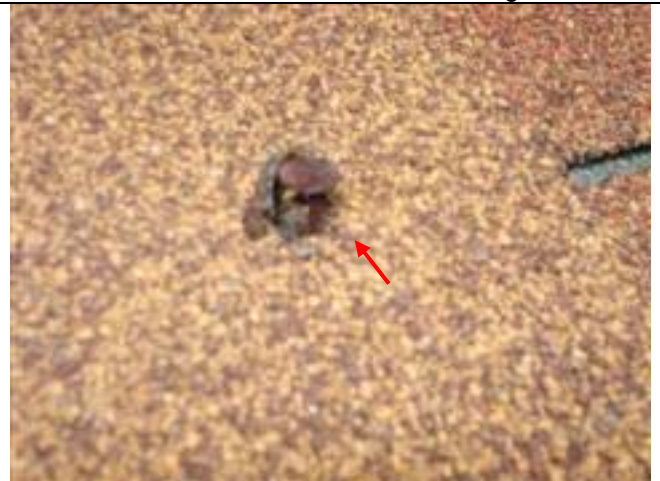
A single nail has “popped” up through shingles over the sun room.

- **Repair:** Any raised nails through the roof covering over the sun room should be re-driven and properly sealed.

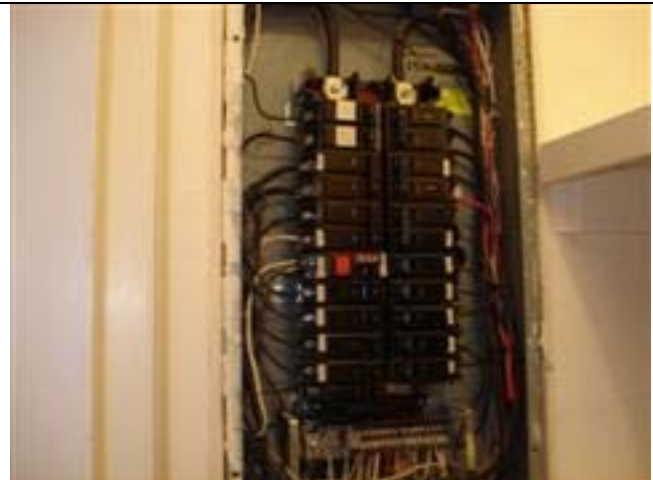
Dead front cover removed for inspection of electrical service panel.

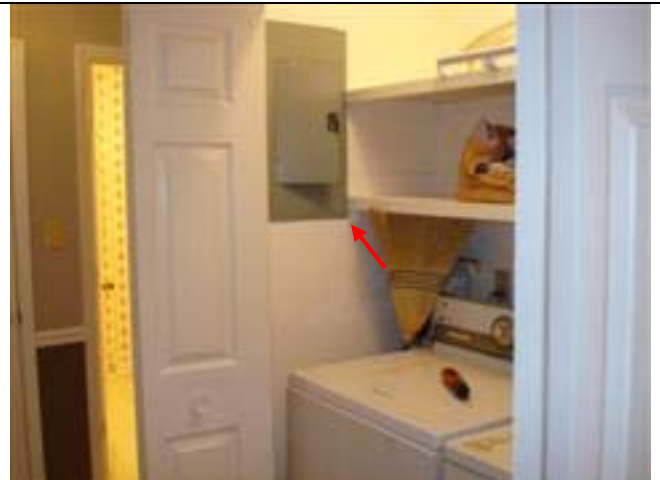
- **Safety:** Access to the electrical panel in the laundry room closet is not in keeping with recommended safety standards. Modern standards state that a 30 inch wide access corridor should exist for at least 36 inches directly in front of the panel box for safe access in the event of repairs or evaluation. In addition, there should be no obstructions in front of the panel from the floor to a height of 6'8". **SEE NCSBC VOL. 4, ELECTRICAL, ART. 110-16.** The safe access corridor to the enclosure is not available at this time. Improvement is recommended for occupant and service personnel safety.

Electrical service panel has restricted access.

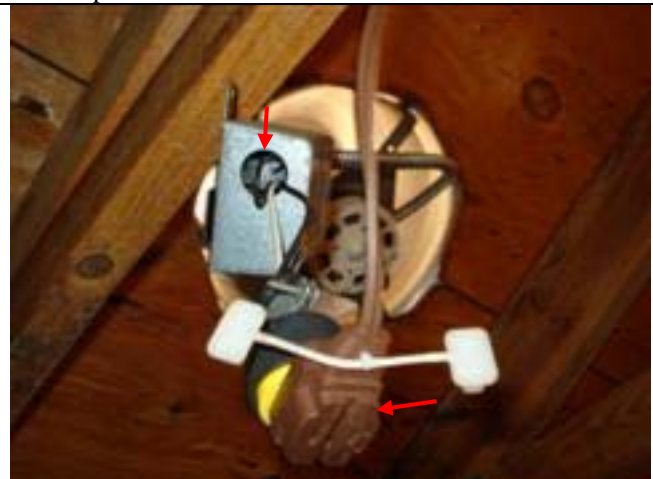
- **Repair:** Lamp cord, not approved for this use, has been used to power lighting in the attic for the attic vent fan. Consult an electrical contractor for evaluation and correction. Improper wiring can be hazardous.

- **Repair:** Improper electrical connections should be repaired in the attic for the attic vent fan. All electrical connections should be made inside junction boxes, affixed to the building frame, fitted with cover plates and appropriately secured at the entrance. Consult an electrical contractor for corrections.

Unsafe wiring of attic vent fan should be corrected immediately. **Lamp cord, missing grommets, powered from receptacle, etc., etc.**

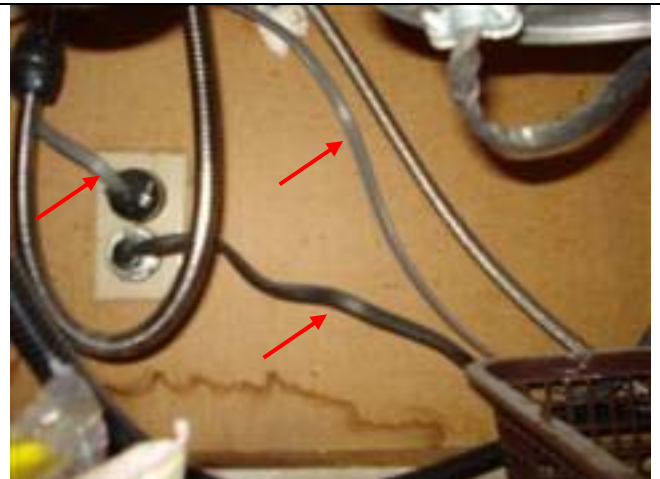
- **Repair:** Wiring (NM/Romex-type) installed inside the sink cabinet is exposed. This wiring type should be covered with a protective conduit when not installed inside a wall cavity, below floors or in attics. Consult a licensed electrical contractor for improvements.

Wiring cables rated for use inside walls and conduit need protection from damage inside kitchen sink cabinet.

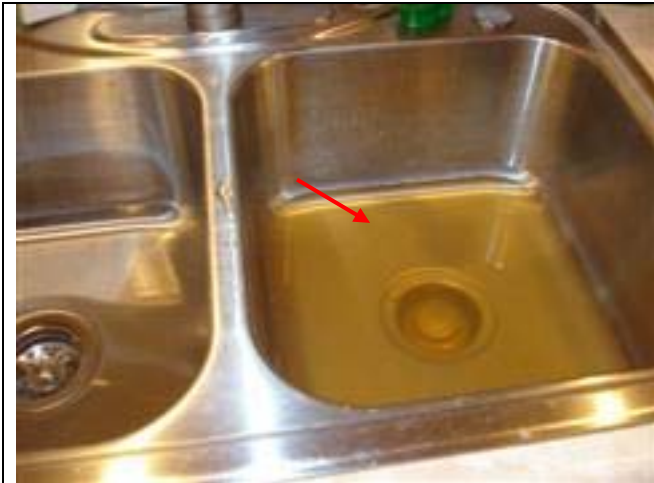
- **Investigate:** The water from the hot water valve was brownish in color. This can occur when water stands inside a water heater that has a steel tank or steel tubing as part of its components. Consult a plumber to determine the cause and remedy, if needed.

Brownish water from water heater.

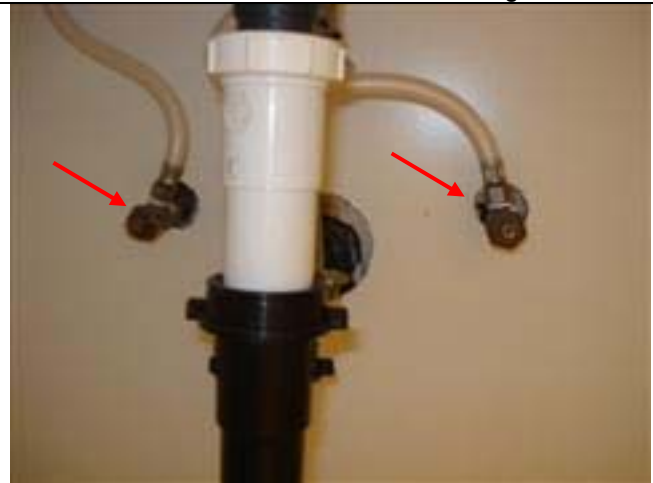
Gate valve handles missing for master bath lavatory water supply lines.

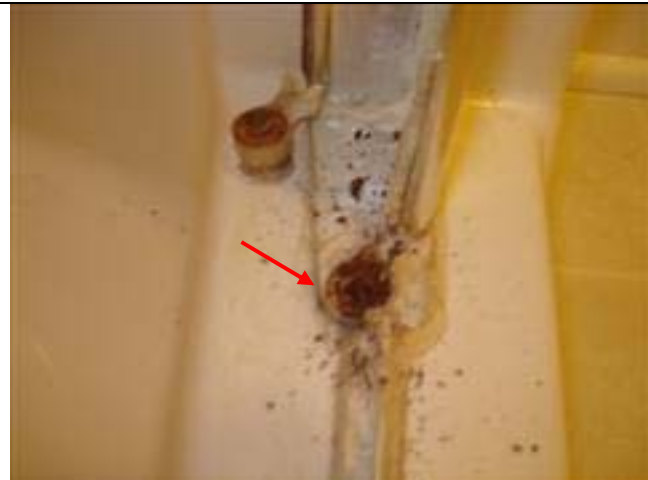
- **Repair:** The glass shower door is off the hinge pin in the master bathroom. If the shower door is not labeled as tempered it would be prudent to replace the glass door for occupant safety as well. Consult a glass installer for repairs and evaluation.

Shower door rusted at bottom hinge pin. Door fell off assembly when opened.

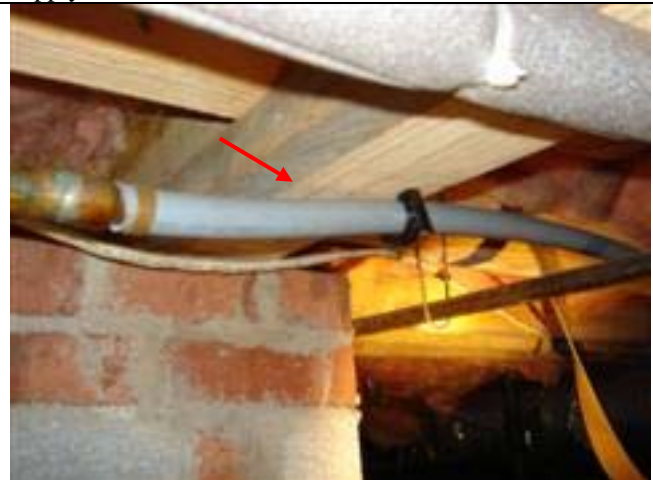
- **Investigate:** Polybutylene (PB / gray plastic) supply piping has been installed in the subject home. It has been used in this area for years but has a higher than normal failure rate. Polybutylene water supply piping is an approved material in North Carolina. For further details contact 1-800-392-7591 or visit the **website: <http://www.pbpipe.com>**.

PB water supply tubing used in crawl space.

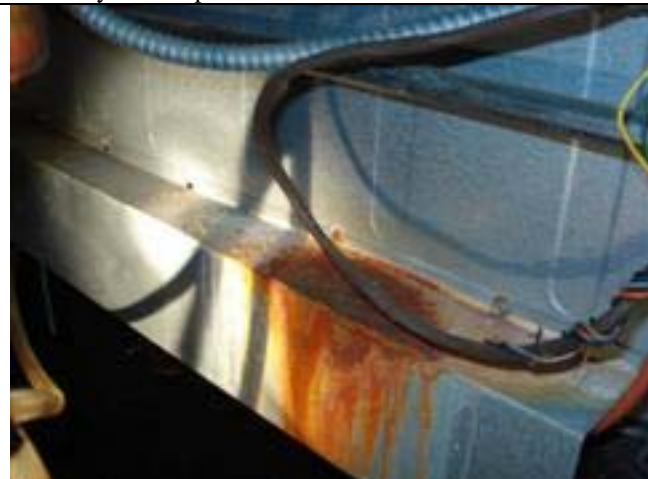
- **Repair:** Leaking condensation from the exhaust vent connection has caused corrosion to the metal furnace cabinet located in the crawl space. Consult a mechanical contractor for evaluation and correction.

Leaking condensate drips onto flare shield of furnace.

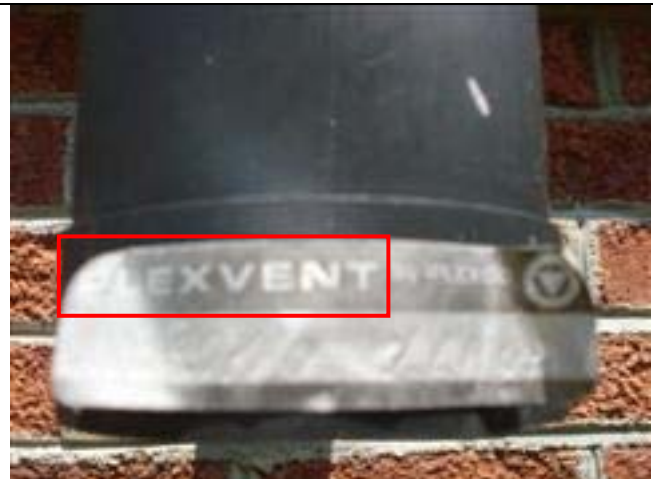
- **Repair:** Thin walled PVC vent tubing has been used to vent the furnace located. Consult a mechanical contractor for information concerning a total recall on the use of "**PLEXVENT**" and "ULTRAVENT" type Fiberglass exhaust venting (typically known in the industry as "high temperature plastic vent" or HTPV) which is in use on the furnace. The industry was notified in February 1998 of the Corrective Action Plan (CAP/ dial 1-800-758-3688) which stipulates that qualifying installations be retrofitted with type "B" multi-walled, metal vent pipe or other acceptable vent system. A cracked vent can result in toxic fumes being released inside the furnace area and migrate to other occupied areas under some conditions. Although no evidence of vent cracking was viewed during the inspection, this can change at any time. To view the recall notice on the internet, go to: <http://www.cpsc.gov/cpscpub/prerel/prhtml98/98072.html>. All thin walled HTPV should be replaced for occupant safety. (**PLEXVENT is specifically named in the recall by the CPSC.**)

PLEXVENT exhaust venting is specifically recalled by the CPSC.
